# Test Report

KOMERI-0307-18T1580

- Name of Product : Plastic Terminal Box
- Model : SG-TB-15PT
- Serial No. : -

3. Test Standards : IEC 60529:1989+AMD1:1999+AMD2:2013 Degree of protection provided by enclosure (IP CODE)

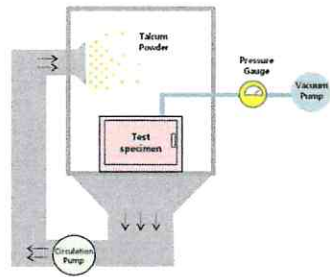
Figure 1-1 IP6X test diagram

- The test samples shall be in place and mounted in the manner stated by the manufacturer.

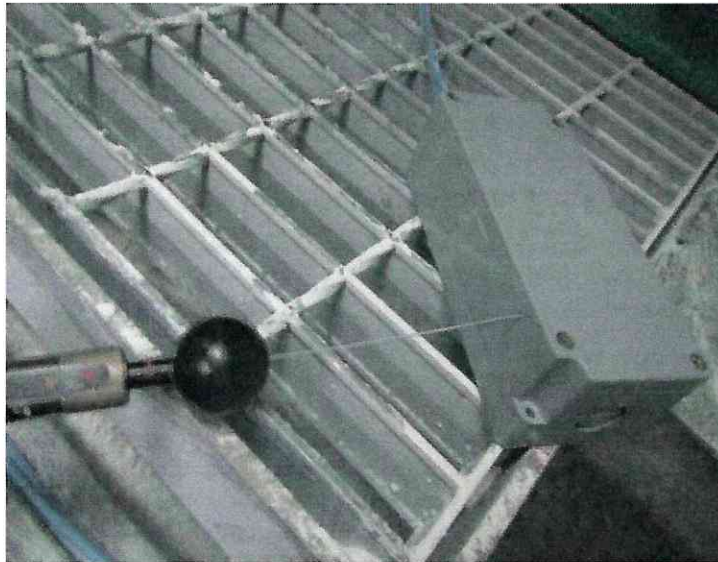
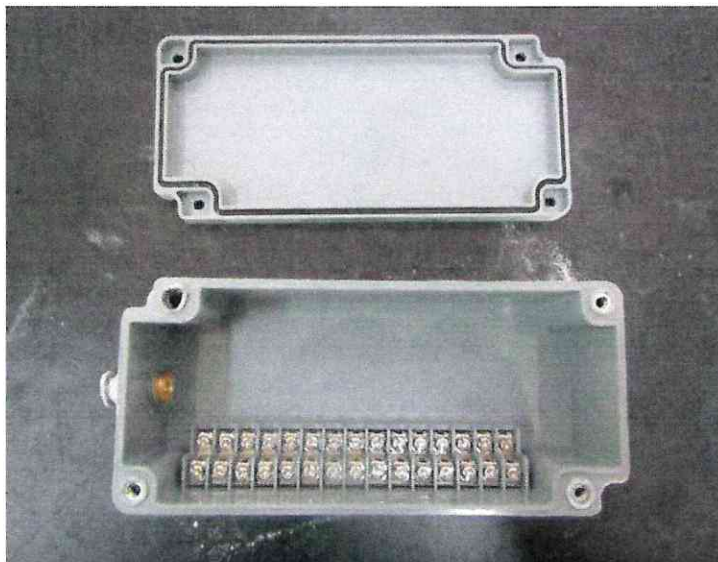
Photo 1-2 IP6X test result

- Test dust and probe did not penetrate into the enclosure through any opening.

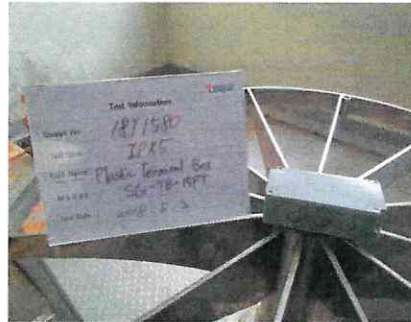
Photo 2-1 IPX5 test set-up

- The test samples shall be in place and mounted in the manner stated by the manufacturer.

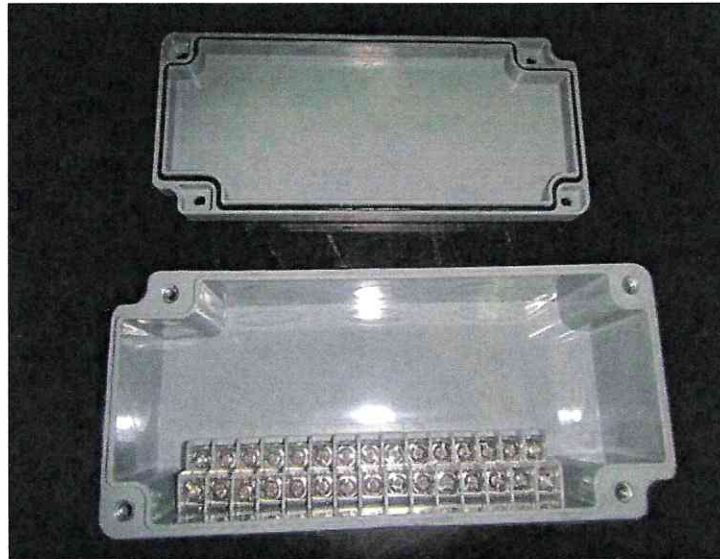
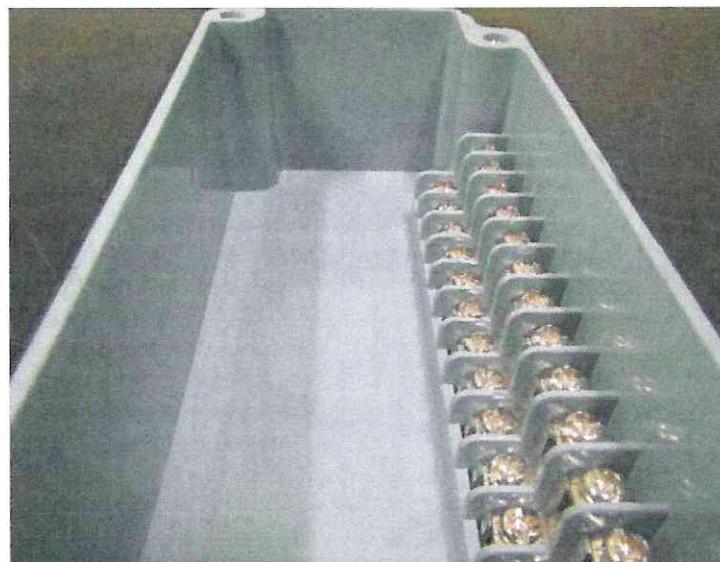
Photo 2-2 IPX5 test result

- Water did not penetrate into the enclosure.
